# ARGENTINA'S FIRST VALVE FACTORY

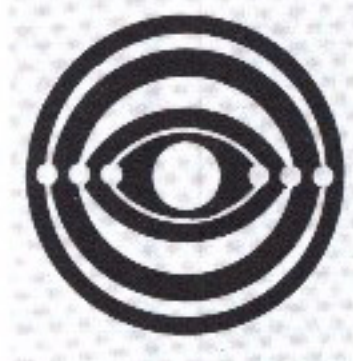
Fig. 3. Brass pattern for a type 43.

each type of valve, of course). The brass pattern for a type 43 (looking down at the top of the valve) is shown at Figure 3. Assembly tools included a small spot-welding machine, the brass pattern, tweezers, and a magnifying glass. The various parts were placed into the pattern which held them in exact position. Next the mica lower supporter was installed. The parts were now

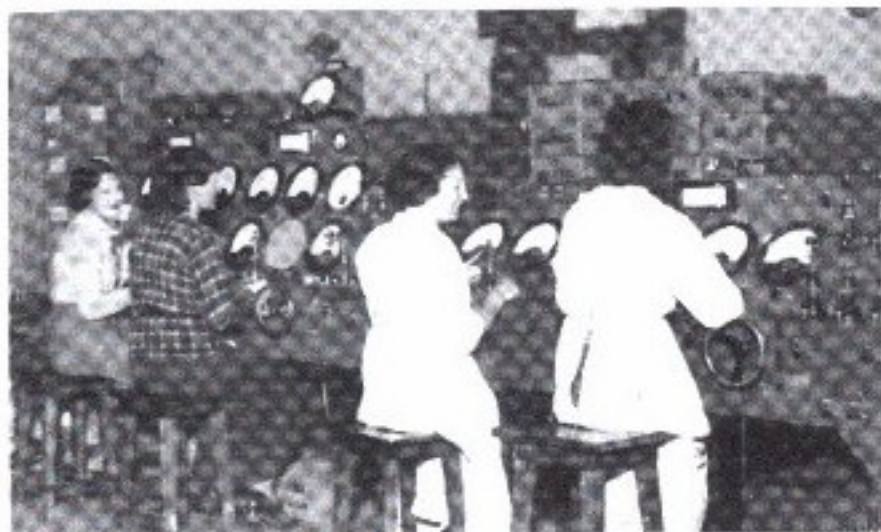
*Left: The final electronic testing station. Right: Typical S.A.I.R.A. valve and box.*
